Item 6.1 Eye-pin and ring fittings on Julian's wall surface.

Item 6.2 Mooring bollards on Julian's wall

Item 7: Stanchions (reused)

Item 8: Bluestone kerbing

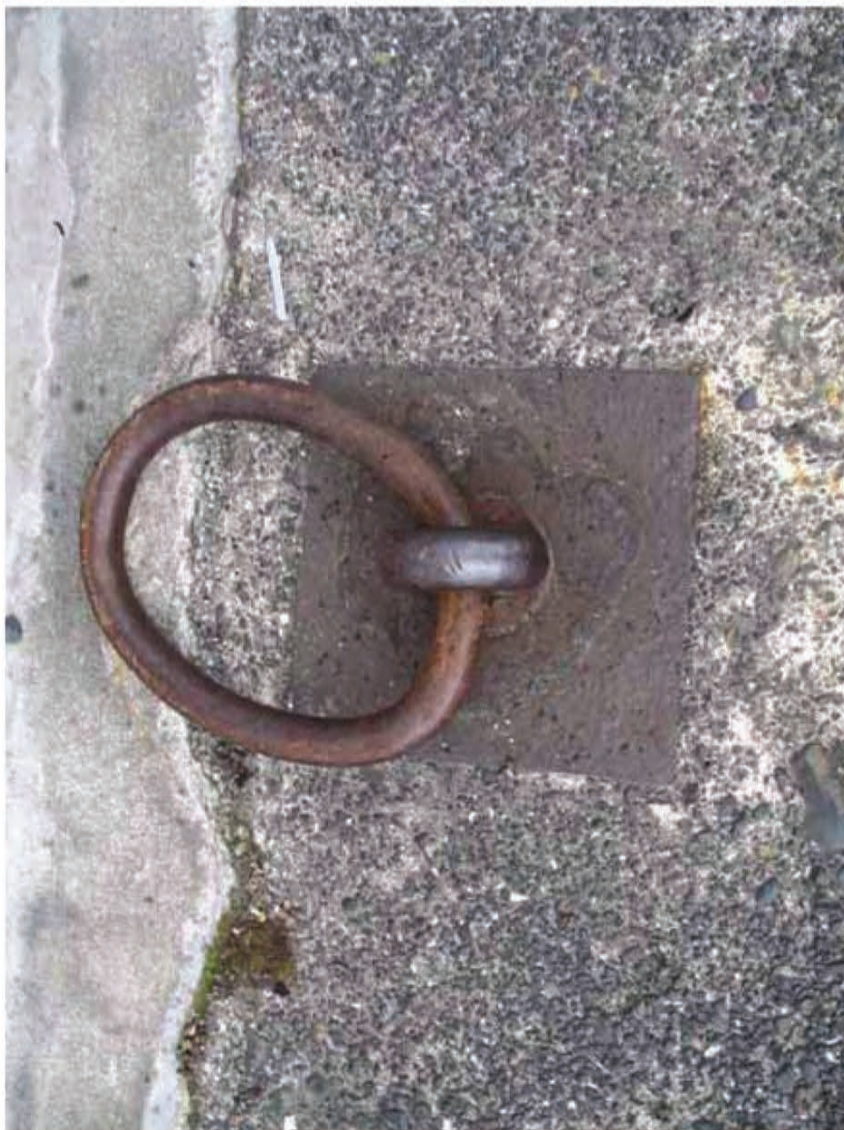
3 x iron eye-pin and ring fittings mounted in old concrete surface of wall that formed original eastern side of Freemans Bay reclamation. One has had the fitting sawn off.

2 excellent, one poor (damaged).

Exposed aggregate surface of Julian's wall (right) with eye-pin and ring fitting.

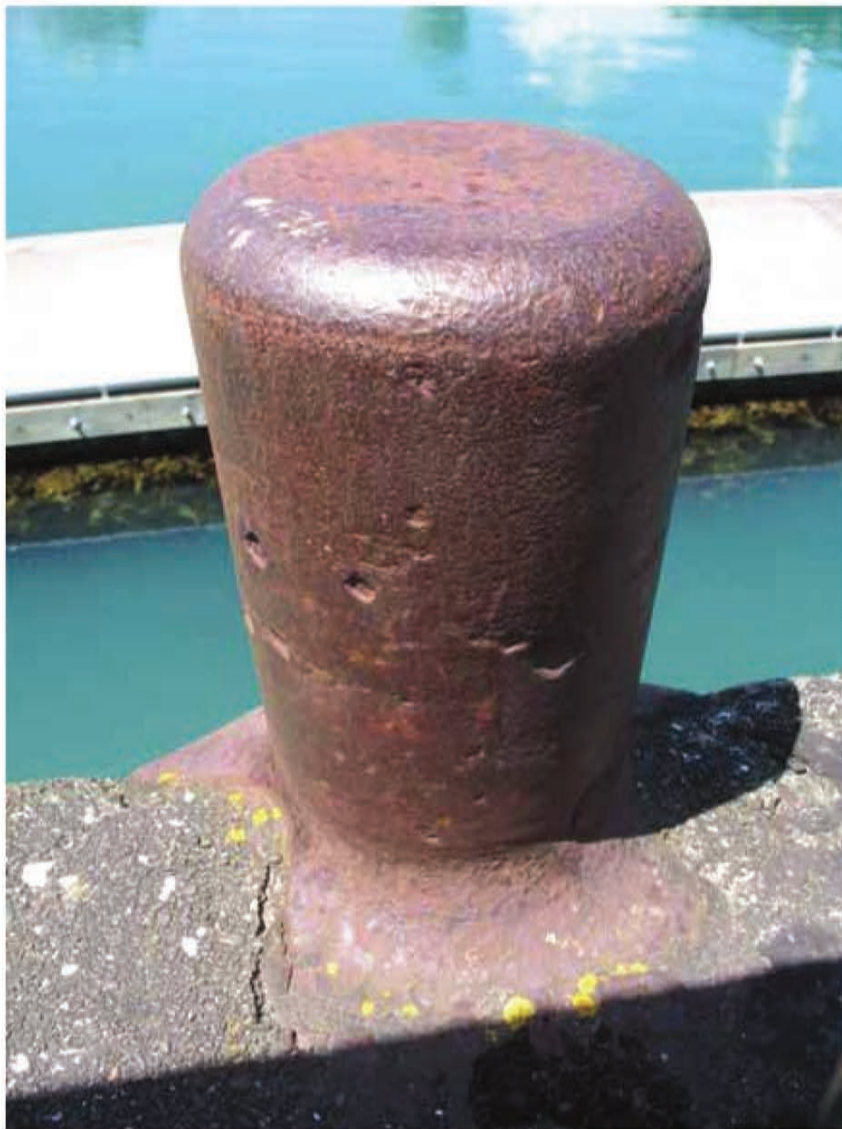
2 x plain AHB cast iron mooring bollards mounted on exposed section of Julian's wall.

Very good (not viewed at close range).

One of two remaining bollards on the exposed section of Julian's wall.

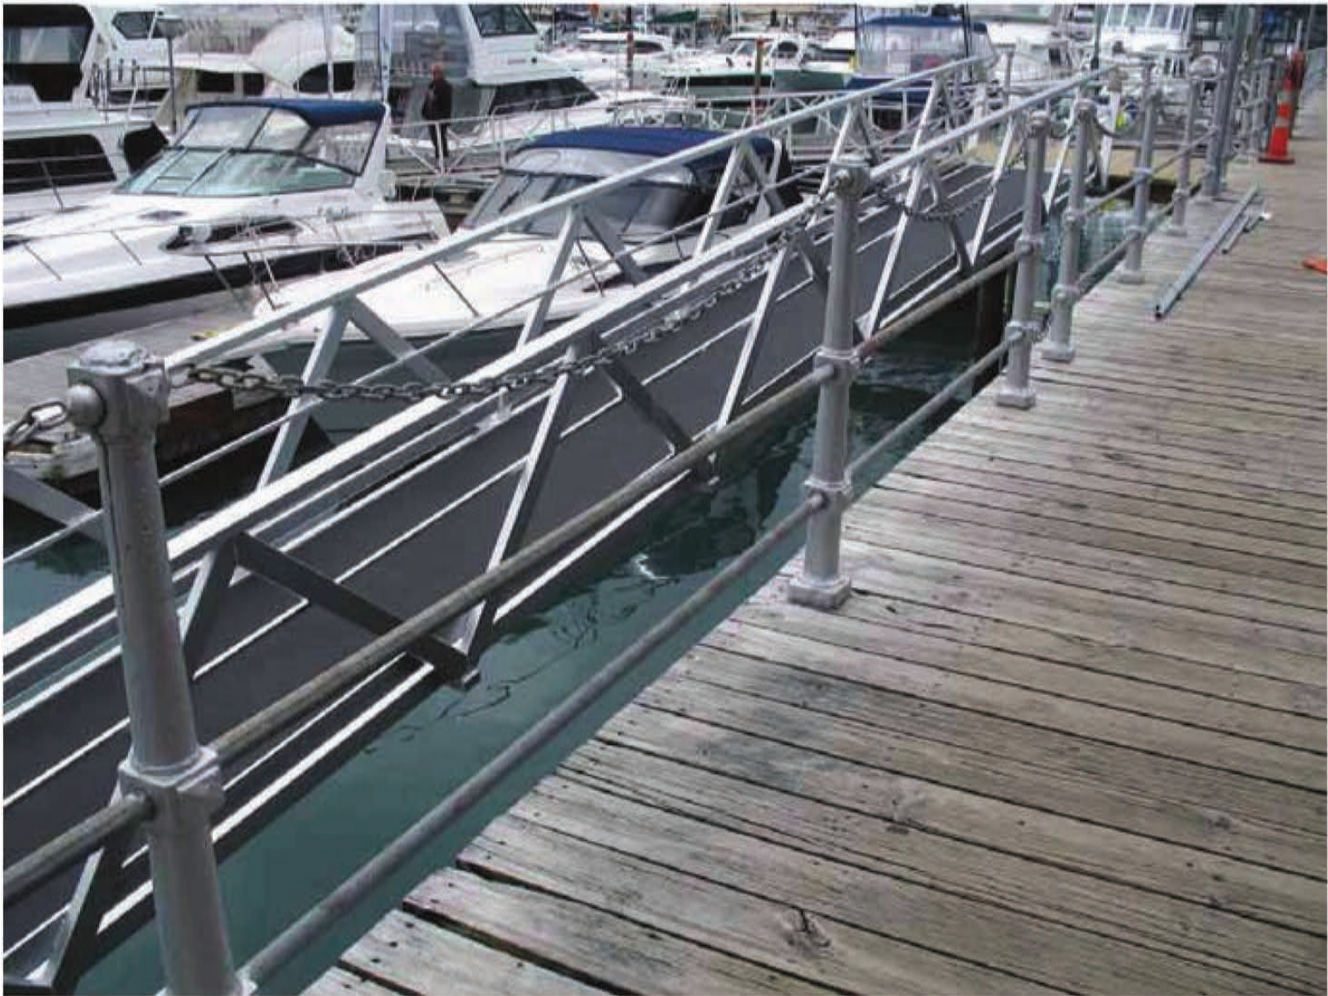
AHB pattern cast iron stanchions, reused on modern jetty with galvanized pipe railing & chain. The balustrade is approximately 80 metres long.

Good, heavily sandblasted.

Modern balustrade incorporating recycled stations, Pier 21.

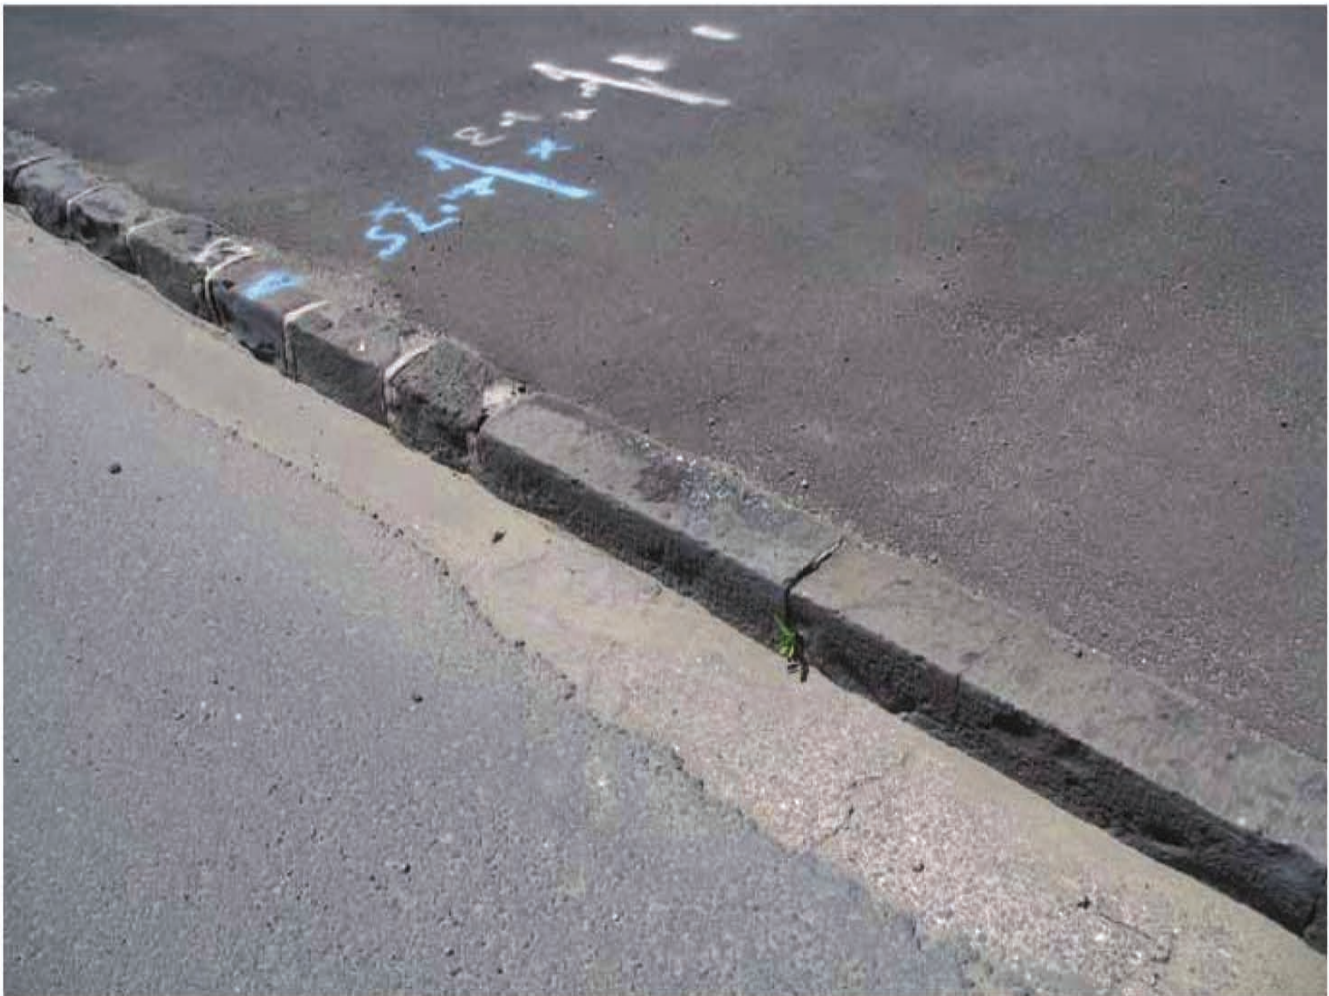
Bluestone kerbing has survived along most streets except where interrupted by vehicle crossings or has been replaced with modern concrete alternatives. In places there are also original bluestone paved vehicle crossings. A variety of finishes are represented - some kerbstones are hand spalled, others are more regular and appear machined.

Generally very good. Only a small proportion has been re-layed and thus much of the kerbing retains its original spacing and detailing, now lost over much of the city.

Bluestone kerbing , Beaumont St: Kerbing with original stones & detail on right, modern replacement on left.

Significant character element, potential for lost sections to be reinstated.

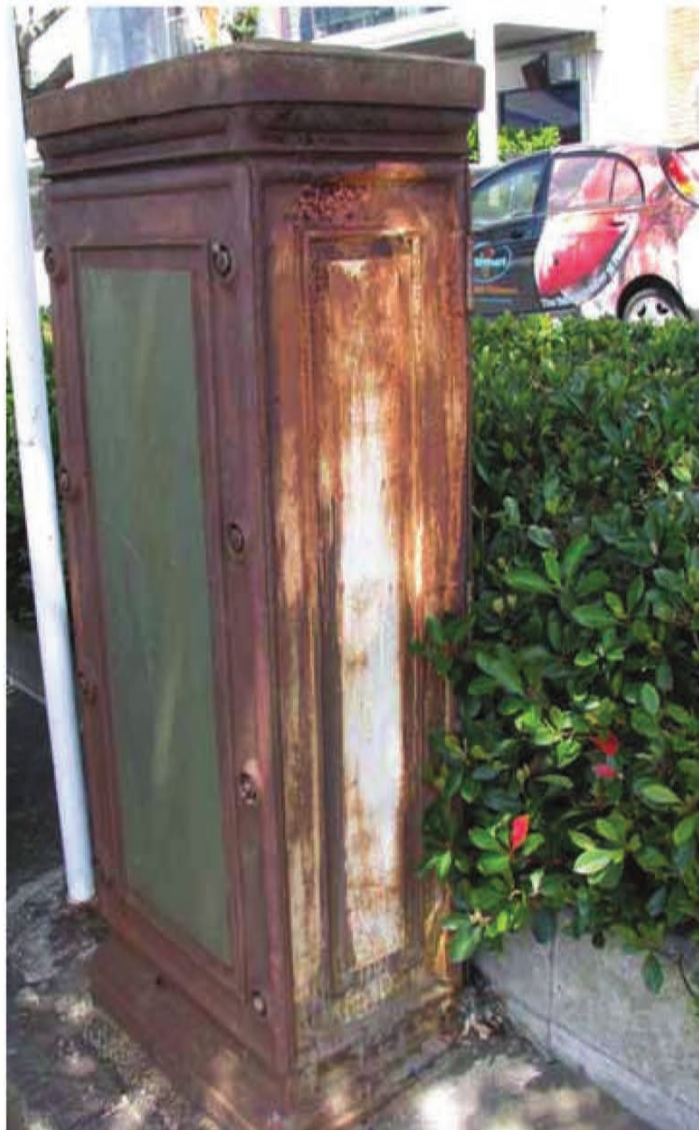
Item 9: Cable junction box

Cast iron cable junction box (probably telegraph/telephone). Embossed Henley HTW London.

Excellent, cosmetic surface corrosion.

Cable junction box, Jellicoe Street
