## Item 4.2: Mooring bollards

### Item 4.3: Hinged iron service covers

## Item 5: Drain/channel lined with bluestone blocks

## Item 6: Julian's wall

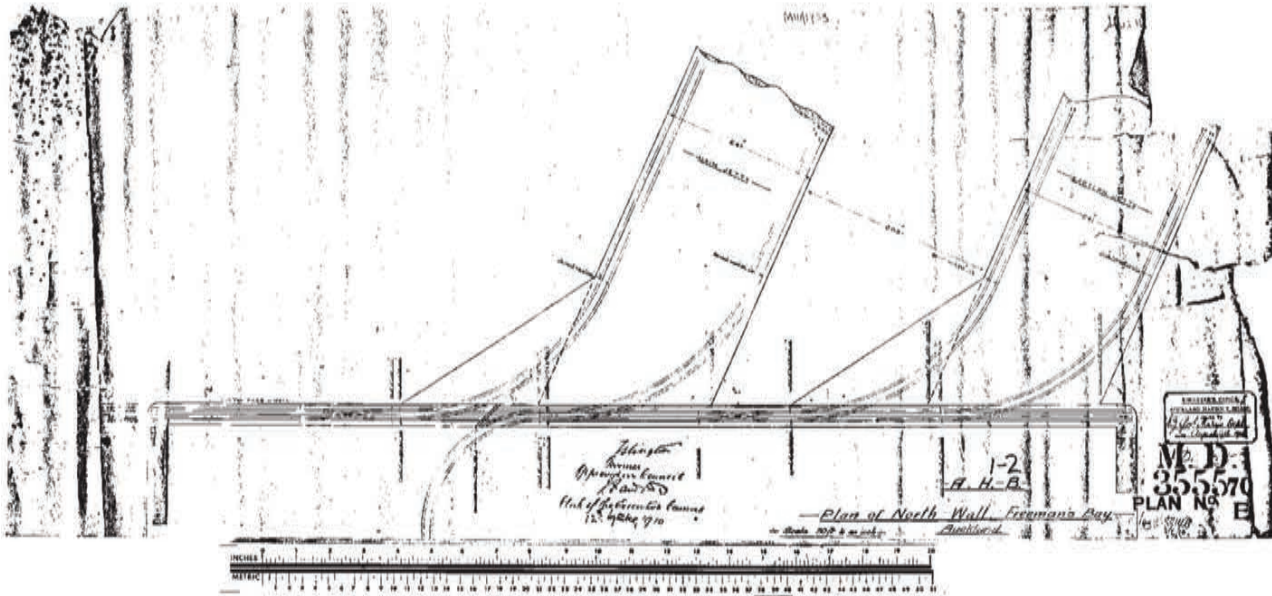
Original plan for the north wall of the Freemans Bay reclamation showing proposed main (now Wynyard Wharf) & eastern jetties and rail tracking. The tracks leading to the eastern jetty were laid and are still in place but the jetty was never built. MD plan 3555, 1910.

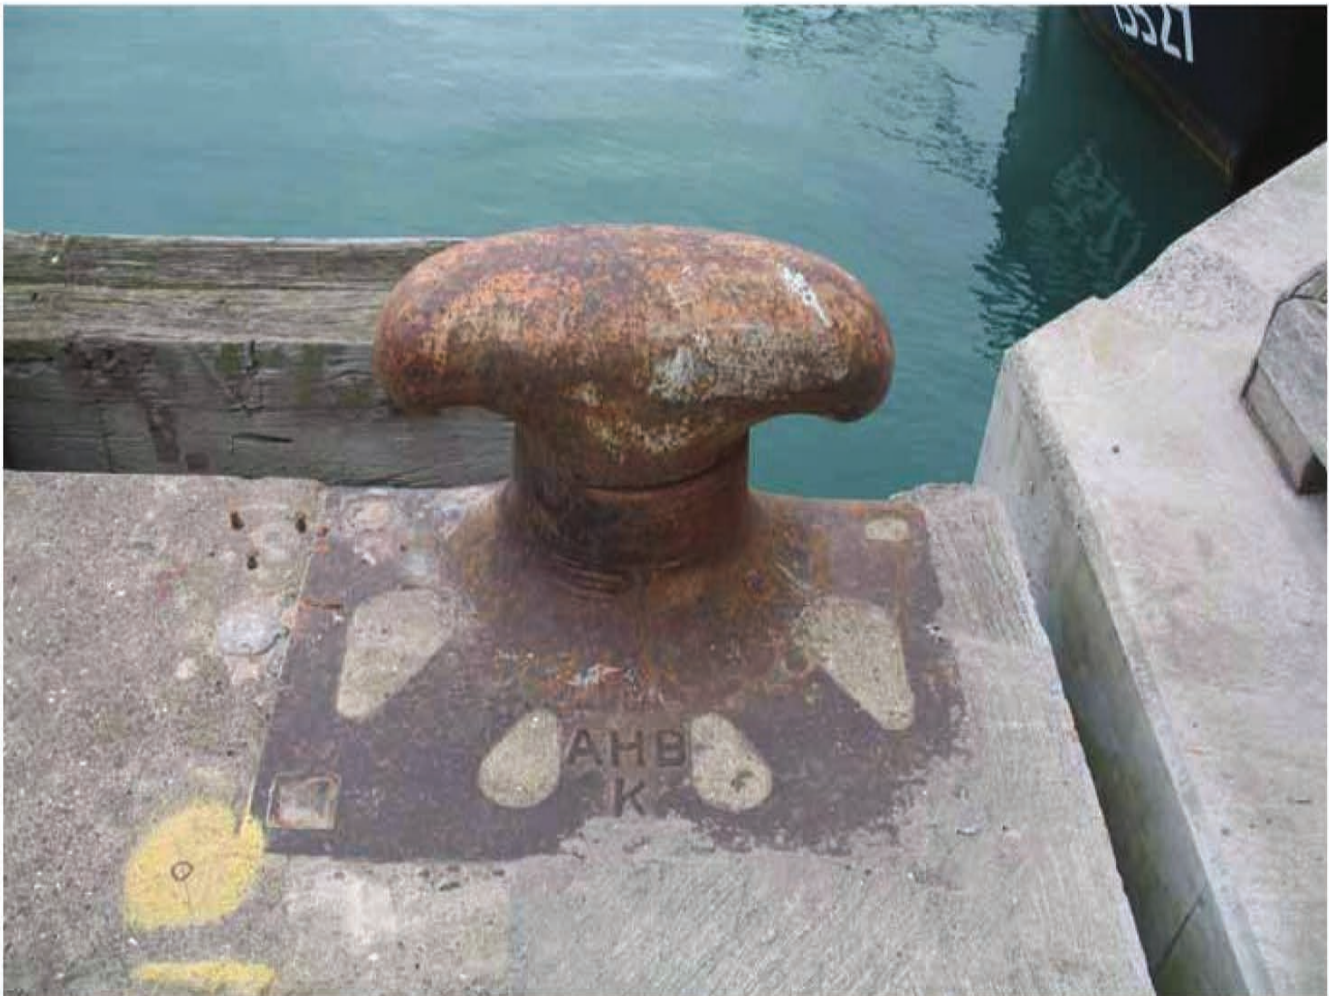
Embossed cast iron AHB bollards x 12 mounted along East/West oriented North Wharf edge. Mixture of type K (pictured) type L, and type M. There is also a type M bollard on the Wynyard Wharf alignment beside the car ferry ramp, aligned with and matching others along Wynyard Wharf (enclosed behind protective fence & not accessible).

Mostly excellent. Some exhibit surface spalling of corrosion on mounting plate.

Type K bollard at eastern end of North wharf. Note textural difference between exposed aggregate surface of the historic wharf (far left) and modern wharf to right.

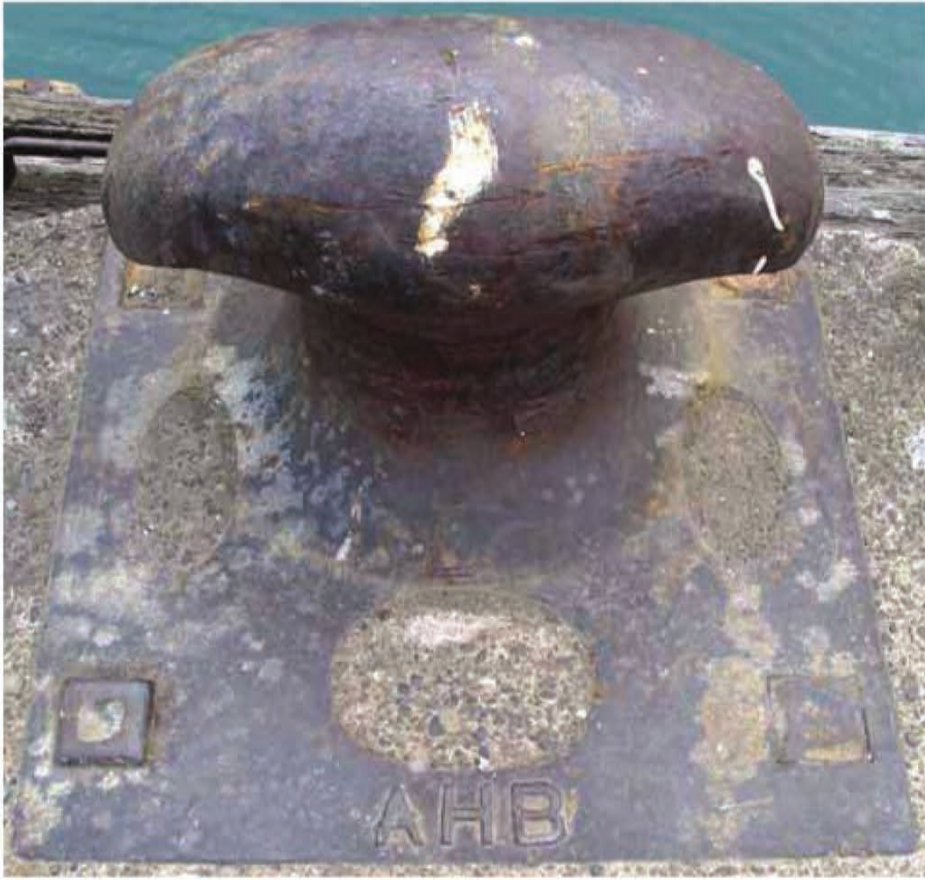
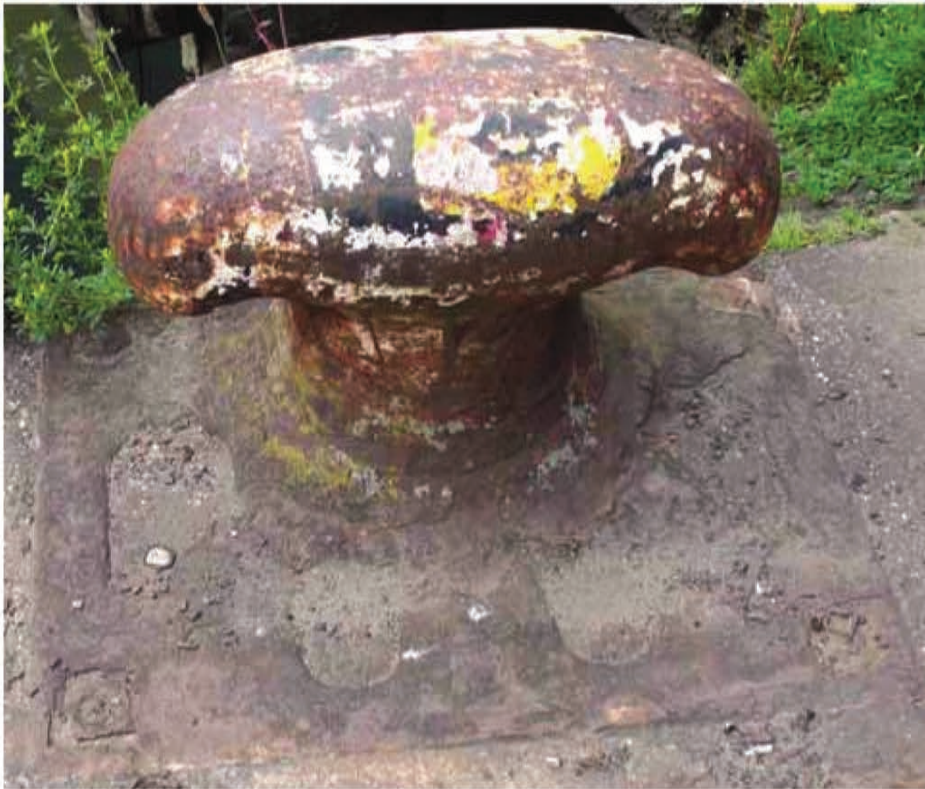
Type L (top, North Wharf) and M (below, Wynyard Wharf alignment) bollards.

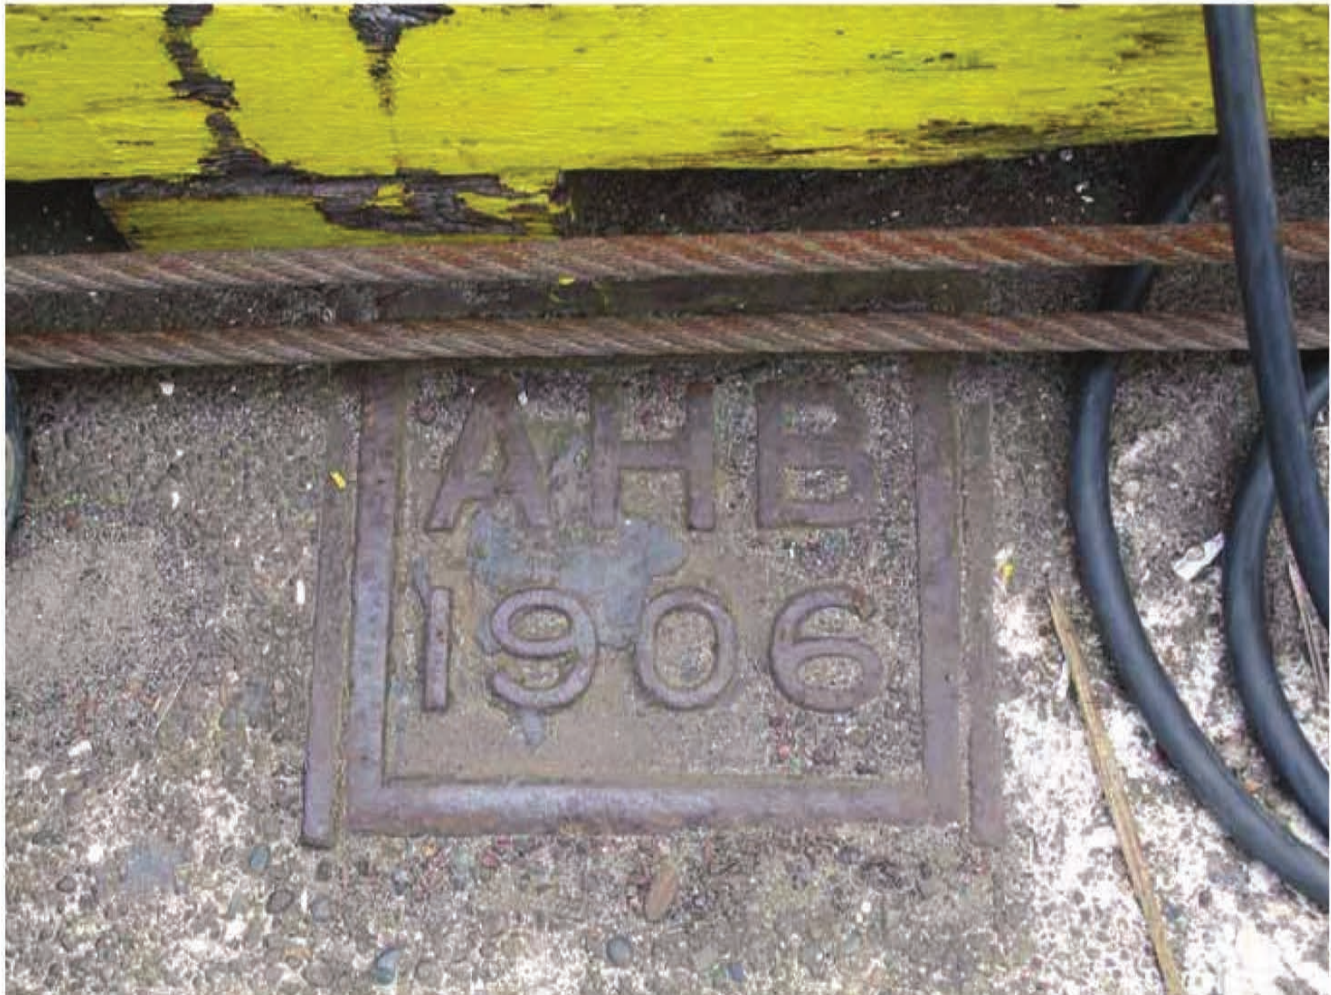
Embossed cast iron AHB covers x 3 mounted along East/West oriented seaward edge of North Wharf. Additional examples may be present under debris or within exclusion zones.

Good.

Service cover, North Wharf.

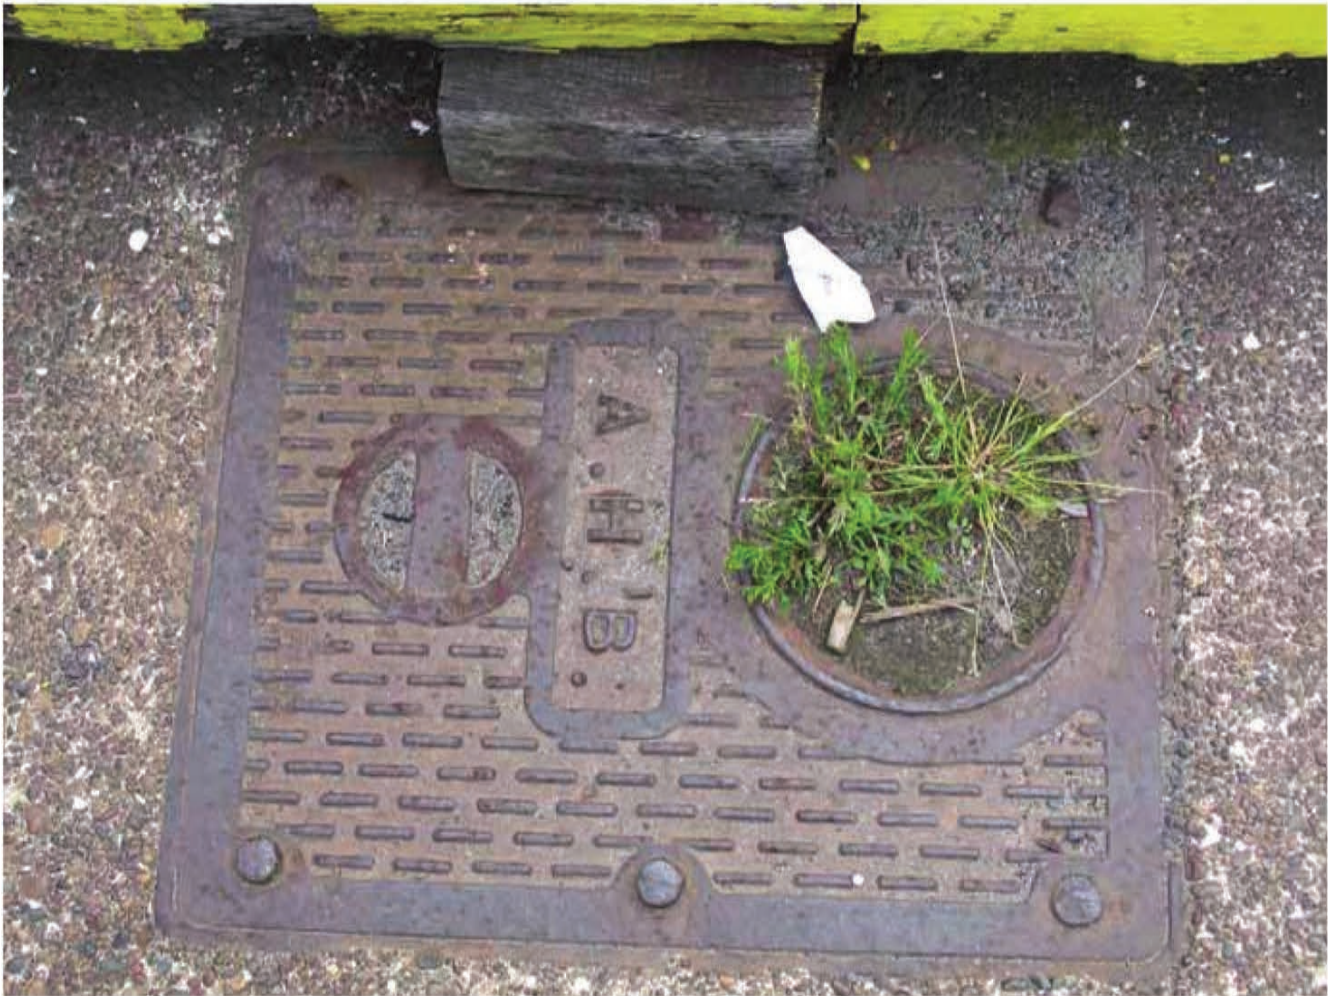
Embossed cast iron AHB fitting with circular hole - probably a davit mount. Along seaward edge of North Wharf.

Excellent.

Cast iron fitting (probable davit base), North Wharf.

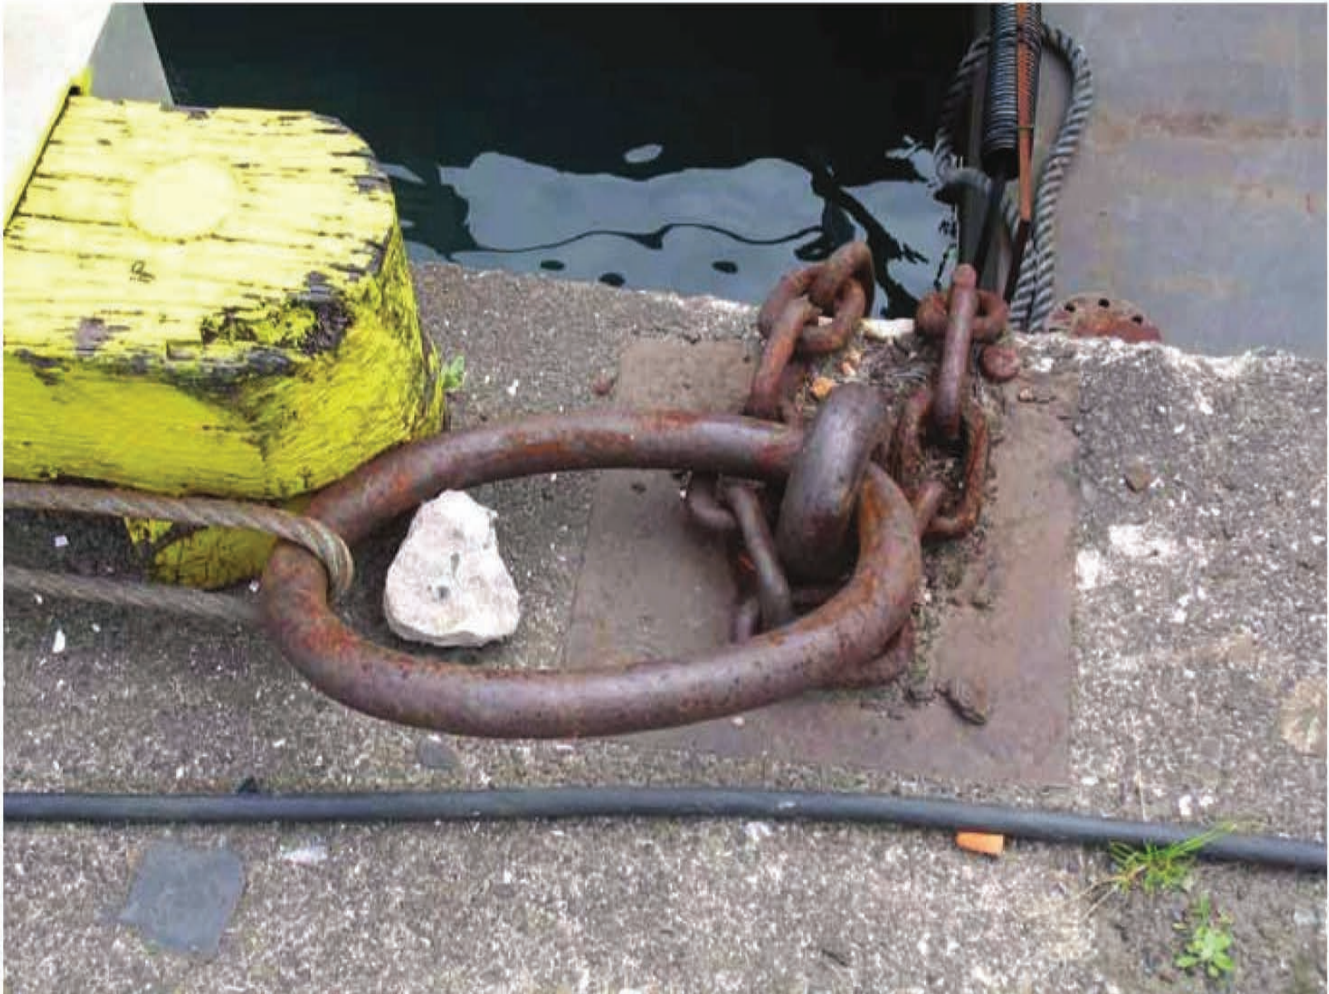
2 x iron eye-pin and ring fittings mounted along seaward edge of North Wharf.

Excellent.

Eye-pin and ring fitting and toe rail (painted, left), North Wharf.

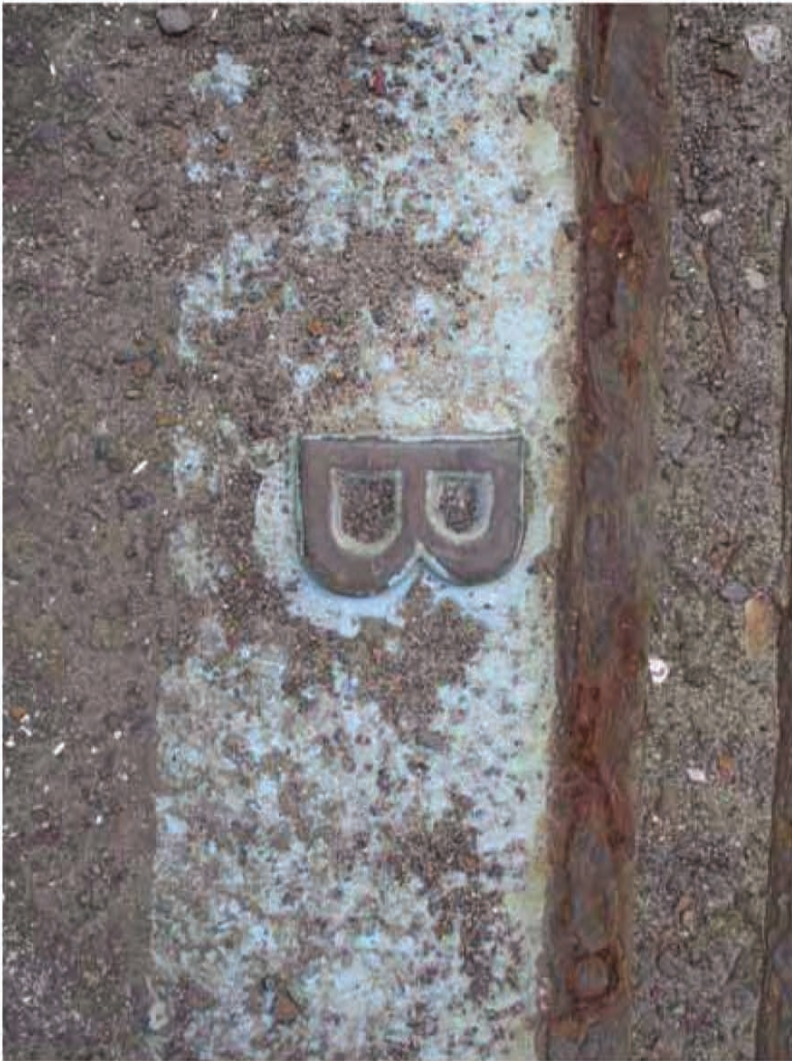
Brass letter B set into concrete.

Excellent.

Letter set in concrete, vicinity of intersection of Wynyard and North wharves.

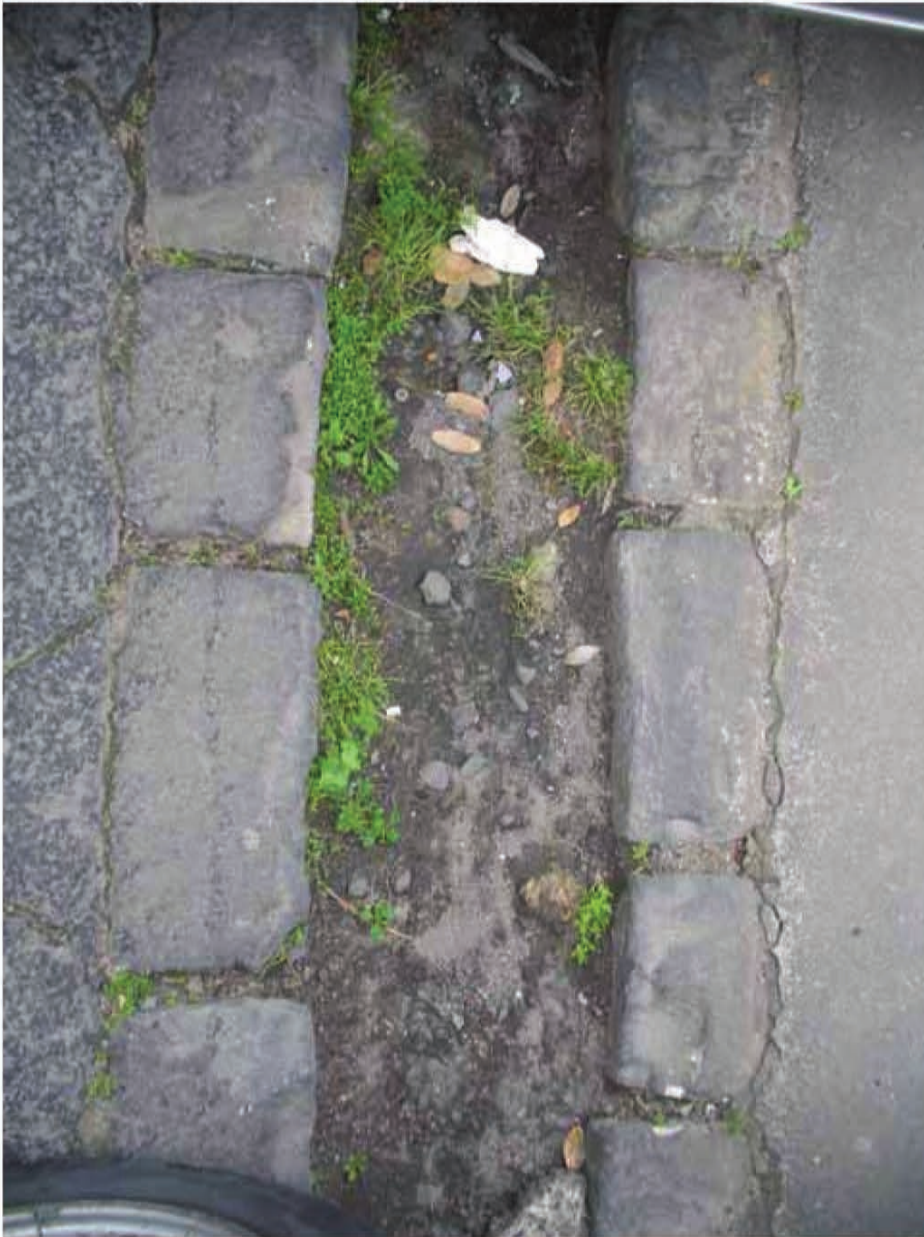
50 m long section of stormwater drain made from bluestone blocks.

Very good. Partially obscured by asphalt in places & infilled with debris.

Bluestone channel, north side of Jellicoe St.

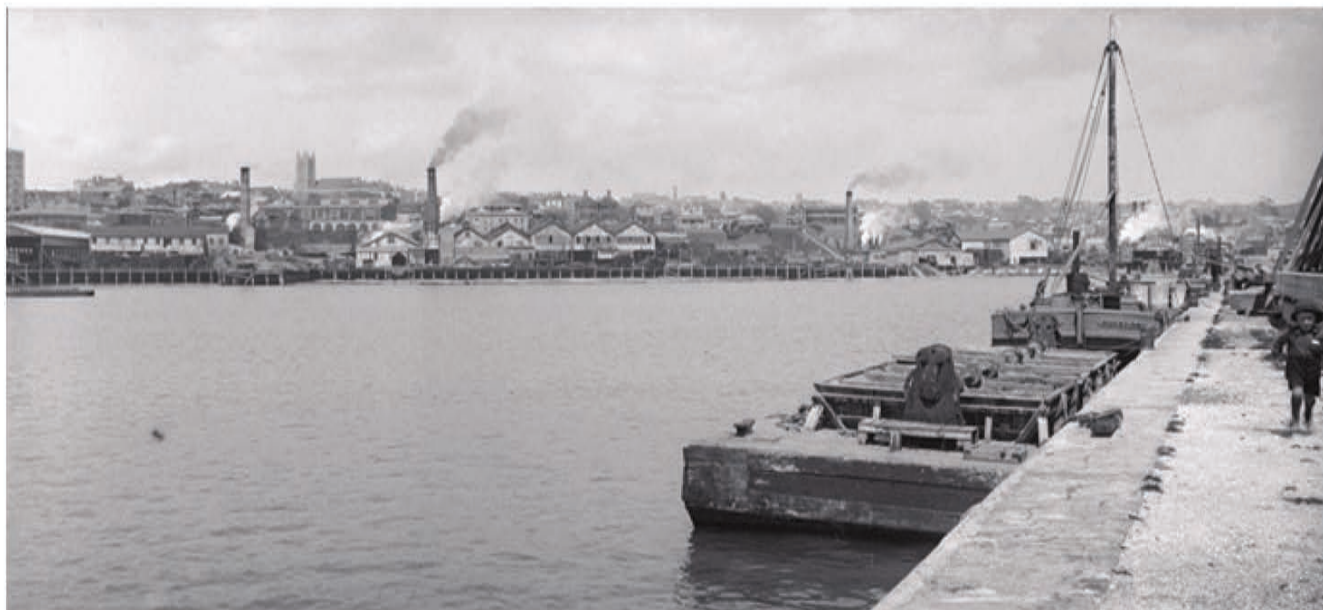
Julian's wall in 1921, with a scow and barge tied up. Auckland Public Libraries.

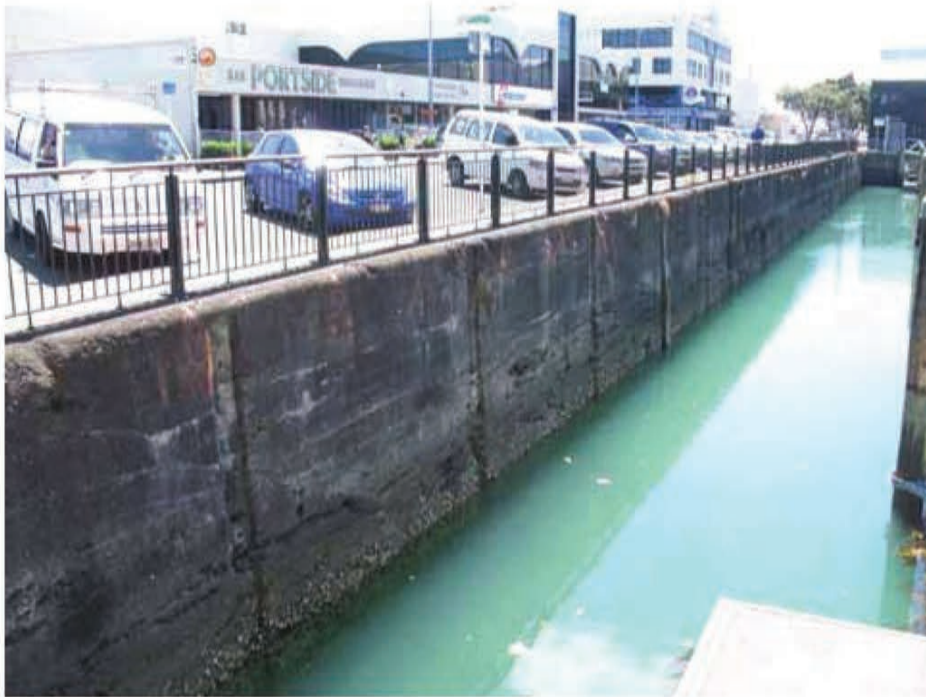
Very good, partially concealed by recent reclamations and later surfaces. Timber fender piles and steel ladder on fully exposed section appear poor (not viewed at close range).

Intact section of Julian's wall, topped with modern balustrade. Note recesses for fender piles and ladders.

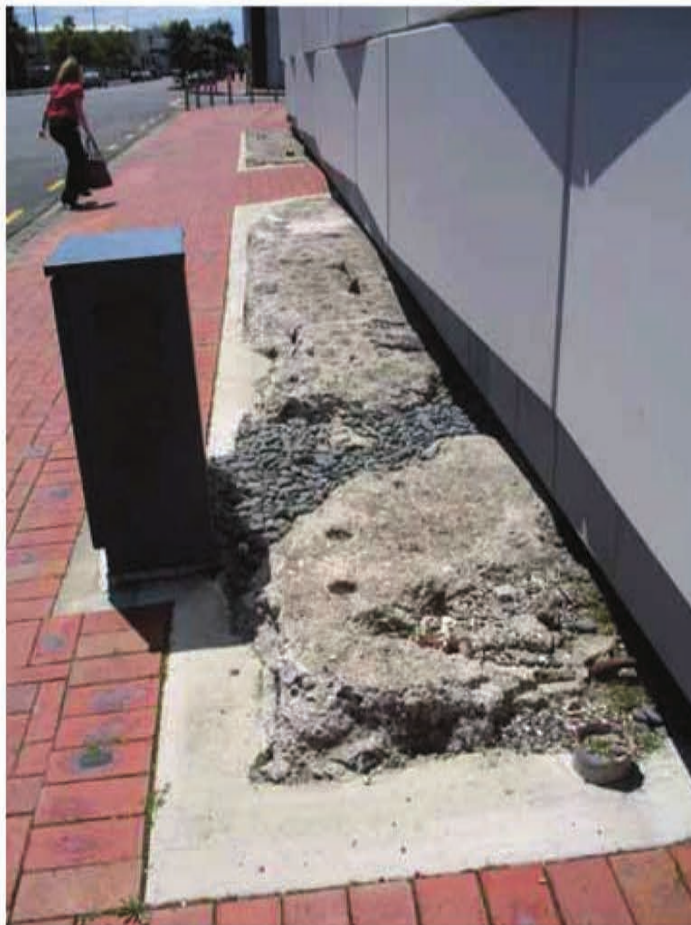
Sections of the top of Julian's wall that have been retained during construction of modern footpath between Viaduct Harbour Ave and Fanshawe Street.
