# **WYNYARD QUARTER INVENTORY OF CHARACTER ELEMENTS**

## **Inventory of Wynyard Quarter character elements**

The following inventory is based on a half day inspection of the Wynyard Quarter. Only publicly accessible areas were inspected.

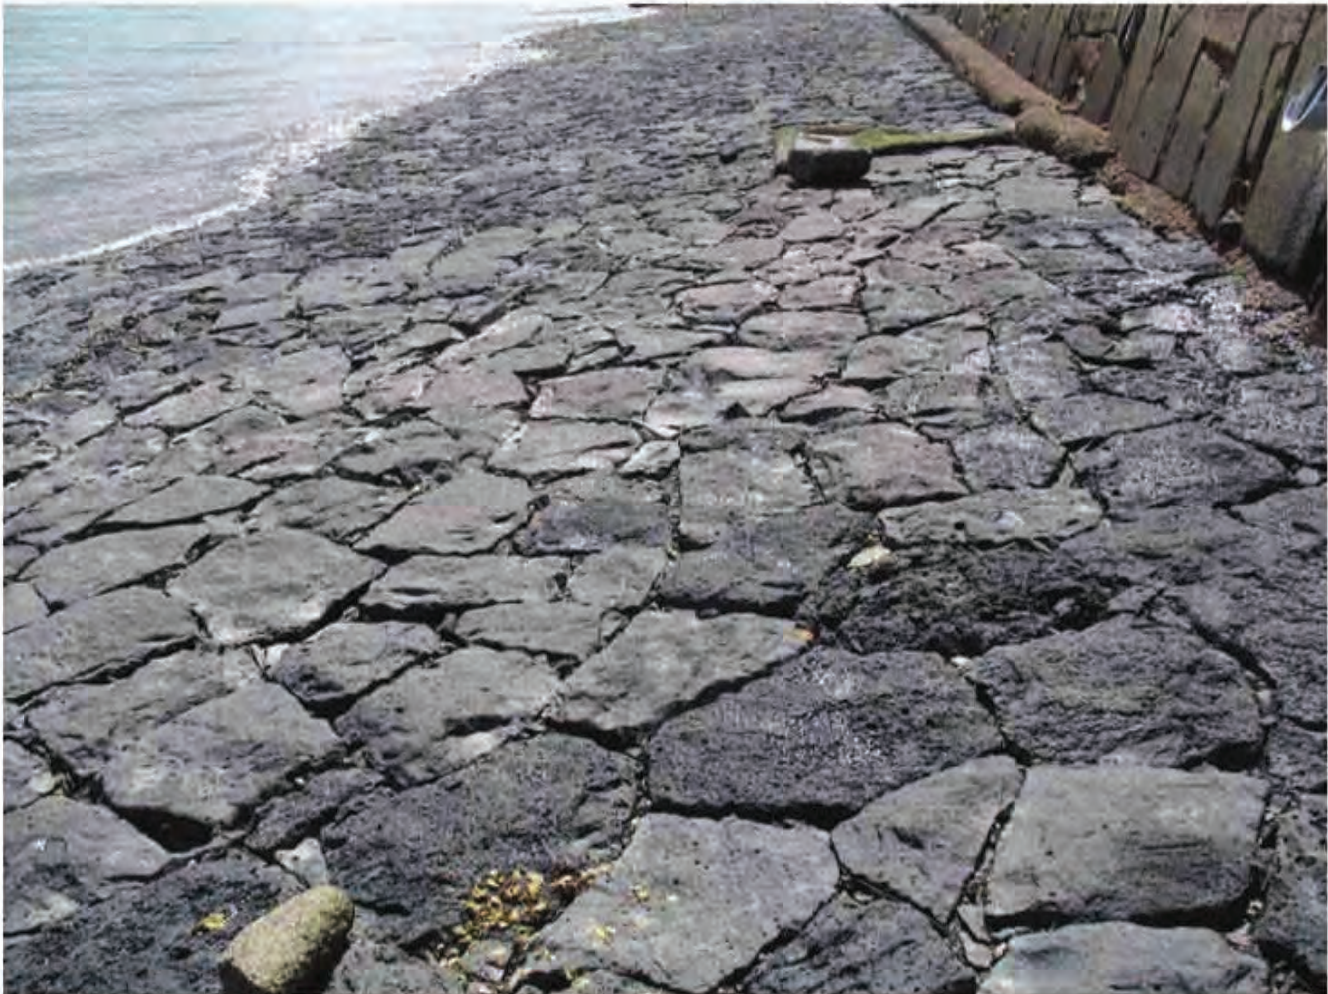
Generally excellent. Part has been capped/overlaid with concrete but this is an early (WWII era) modification and the paved surface appears to be substantially intact beneath. There are also two recent concrete foundation blocks which once provided access to a pontoon, now removed. Condition of southwest end unknown (under rubbish or in commercial premises). Concrete panel seawall (age not determined) behind.

Haul ashore surface, looking north. Concrete panel seawall to right.

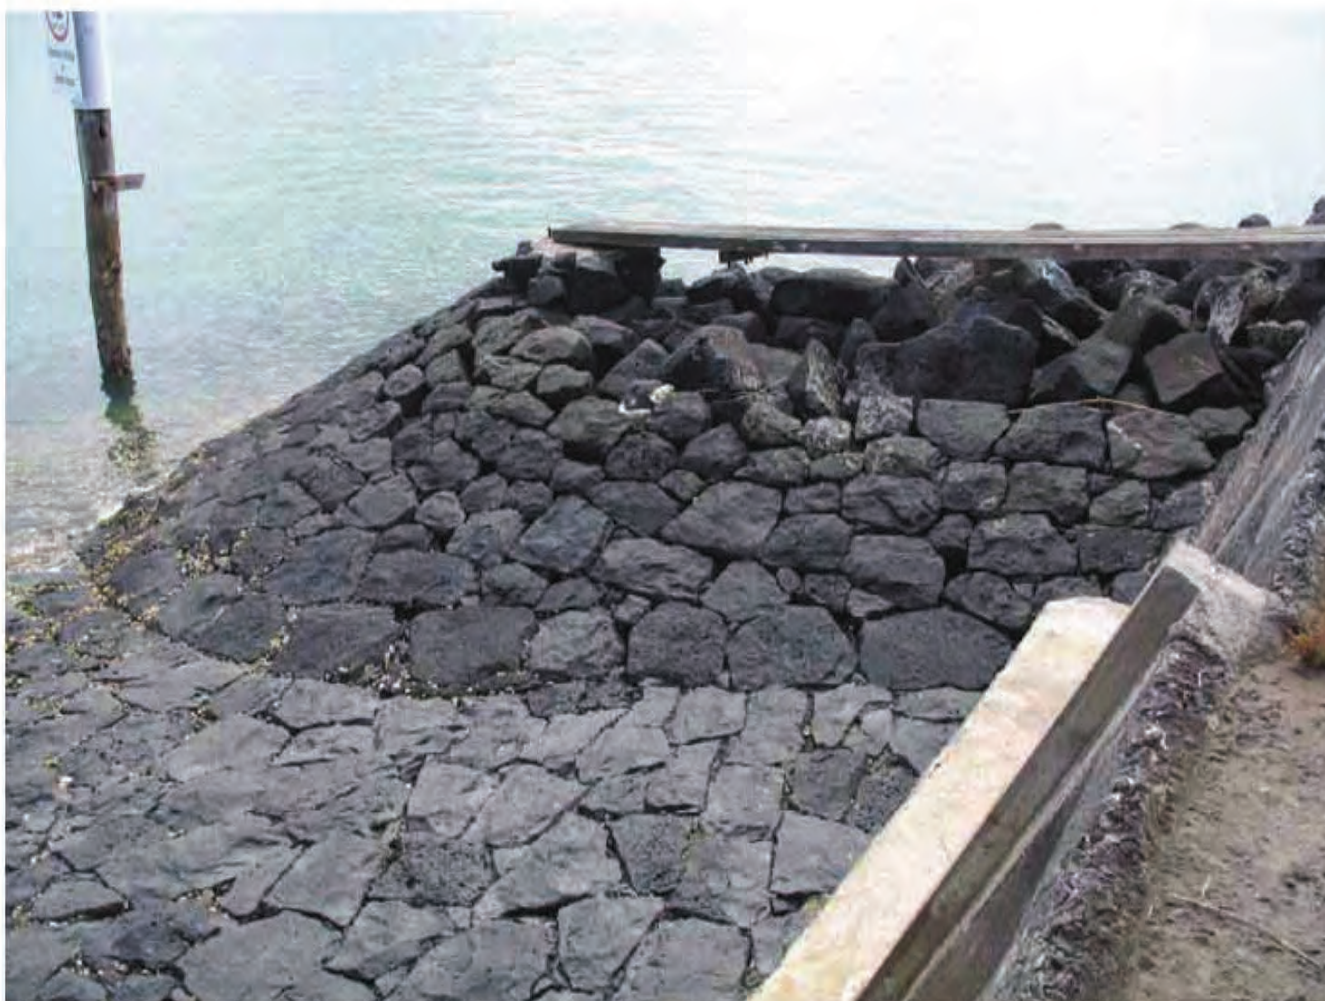
North end of haul ashore - start of rip-rap revetment.

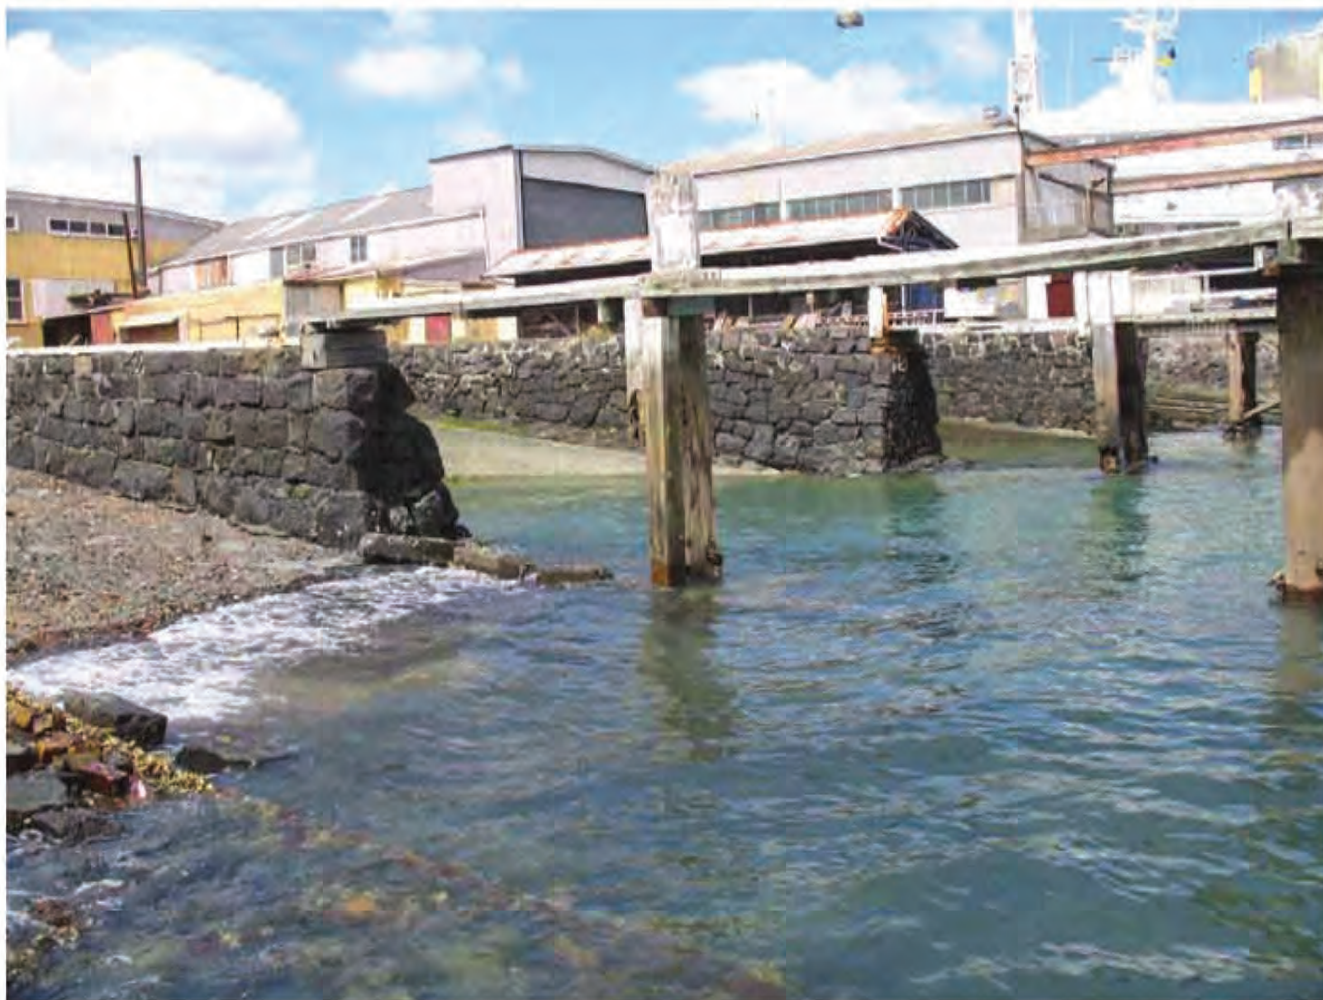
Good. Not accessed or viewed at close range. Some collapse of front face of closest finger evident. Northern end may have been partially modified. Timber foreshore structures appear poor condition. Associated buildings and substantial timber entrance posts remain.

Bluestone slipways and fingers, former Vos boatyard.

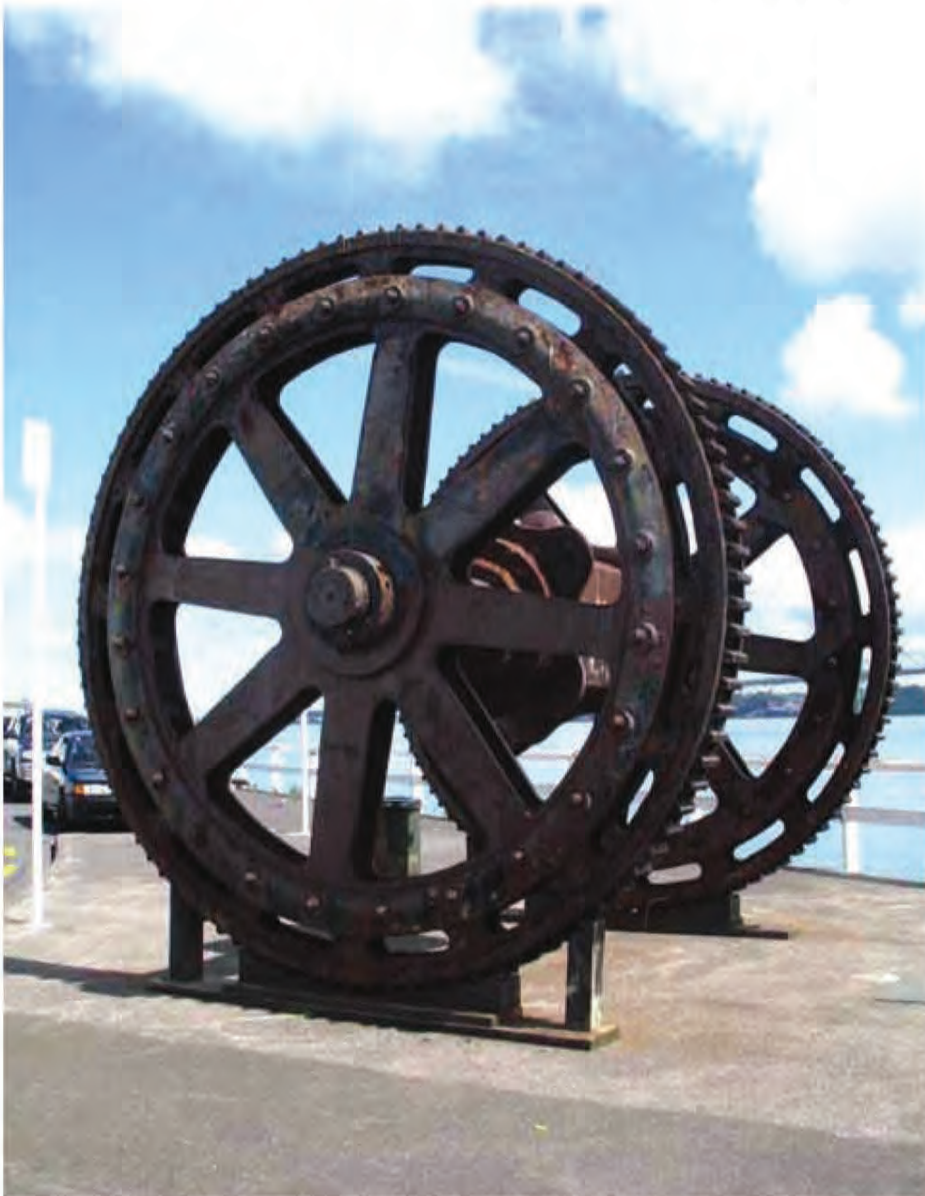
Excellent, surface corrosion.

Mounted driving wheels and plaque (set in concrete, lower right).

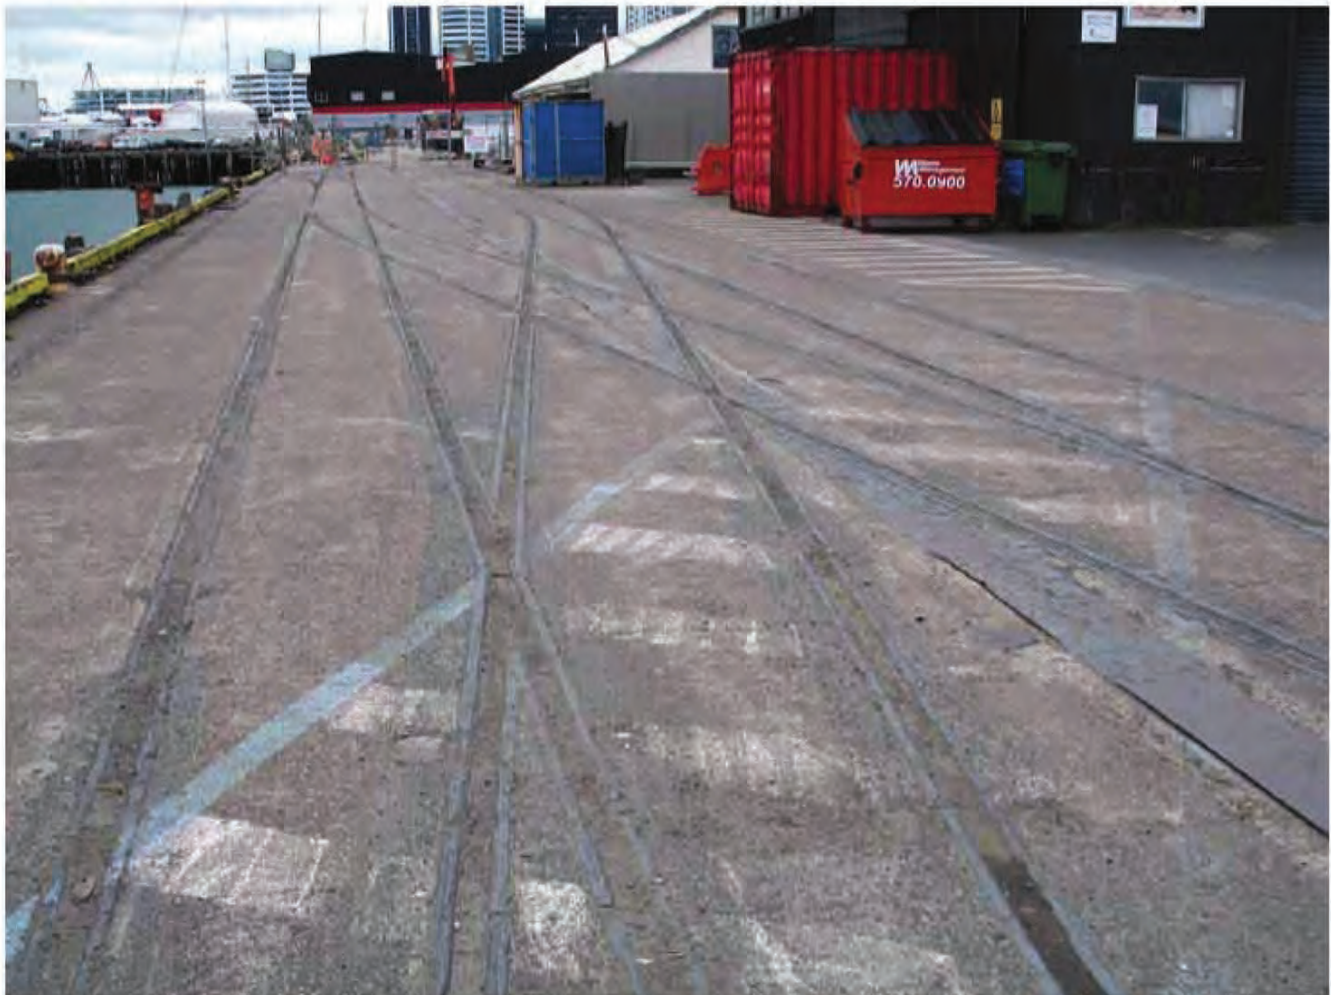
On North Wharf there is a set of 4 parallel tracks straddling a central line of cast iron plates. These are assumed to be travelling crane tracks. There are also 2 sets of railway tracks. Railway tracks are also visible in Brigham and Hamer Streets. Both rail and crane tracks are present on Wynyard wharf.

Variable. Generally in corroded condition, especially plates which are in poor condition in places.

Crane and rail tracks exposed in surface of North Wharf.
